Kingfield Stormwater Project Site Locations

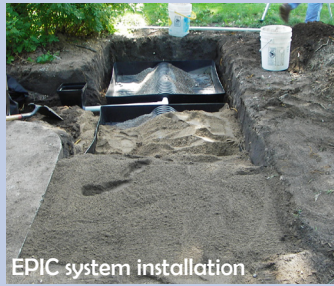
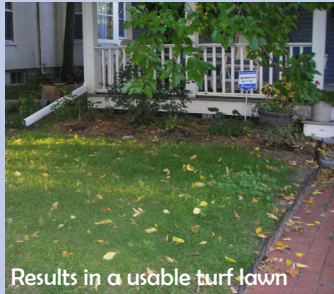
1 226 W. 40th St. \$

- **Project Description:** Two systems on this lot collect water from downspouts and allow it to infiltrate (similar to a raingarden) without giving up lawn. The Netlon System was installed on the west side of the front walkway and consists of thousands of small 2” X 4” polypropylene mesh elements blended into the soil to provide high-load bearing capabilities, stabilize the soil and reduce compaction. Depending upon existing soils, infiltration can be increased by up to 90%. On the east side of the walkway, the Environmental Passive Integrative Chamber (EPIC) system collects and holds 125 gallons of stormwater in 3 underground pans with overflow to a French drain. In addition to stormwater storage, the system provides irrigation for the grass.

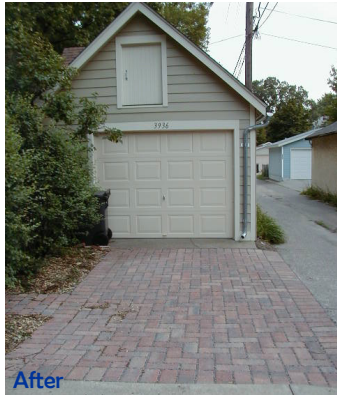
2 3936 Harriet Ave. \$

- **Project Description:** Gutters were installed along the garage and discharge to a 192 sq. ft. porous paver parking area. The paver area was calculated to hold 67 cubic feet of water, more than the amount that will come from the garage. In the design considerations for the paver parking area a shallower infiltration area was not selected due to the freeze thaw cycle and the concern of the pavers shifting. This extra storage space leaves open the possibility of routing additional storm water to this area in the future.

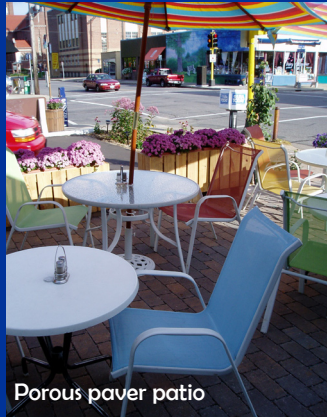
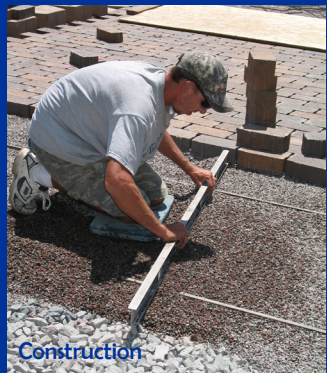
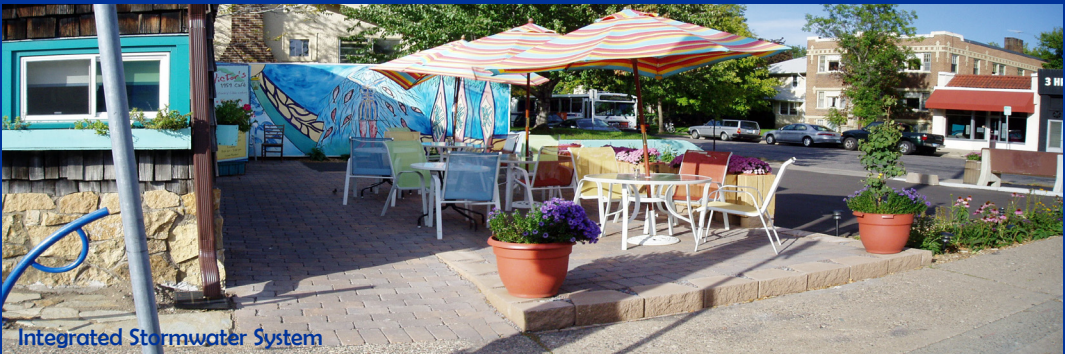
5 Victor’s 1959 Café - 3756 Grand Ave. \$

- **Project Description:** This site was almost entirely impervious and drained directly to catch basins in the street. A porous paver patio, three parking stalls with a turn-around, and a raingarden provide significant stormwater treatment. The porous patio allows rainwater to “soak in” instead of running off into the street. Below the pavers is a layer of rock that stores water and allows it to slowly infiltrate into soils beneath. The roof gutter collects and delivers runoff via underground piping into the raingarden, which also captures and infiltrates runoff from the parking lot.

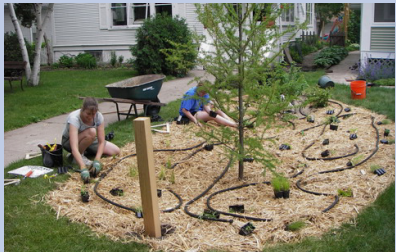
Construction

- **Best Management Practices:** Raingarden, rooftop disconnection, and underdrain
- **Project Description:** A shallow vegetated basin planted with Minnesota native plants (a.k.a. a raingarden) was constructed in the front yard between two houses. Water is conveyed to the raingarden by a splash pad with river rock and a 3” perforated shallow drain tile. Approximately 725 square feet of roof drains to the garden from the two homes, and the garden will hold greater than a 1” rainfall. In the event of a large rain, the rain garden will overflow to the street through a shallow depression at the edge of the garden.

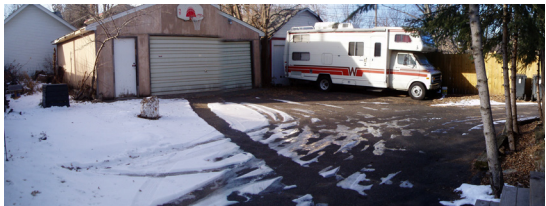
Before

- **Project Description:** The existing backyard and garage area was highly impervious and directed substantial rainwater runoff into the street and stormwater system. The owners implemented a site plan that provides a great deal of stormwater treatment by removing over 1,600 square feet of impervious surface. A garage was torn down and a backyard parking pad was removed, allowing water to soak into the ground. A vegetated swale drains to a raingarden which also collects and treats stormwater from portions of the remaining driveway, house roof, and deck.
